Belzona Saves Rare Windmill

ID: 9174

Customer Location: Derbyshire
Application Date: September 2023

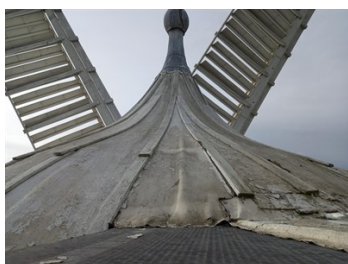
The cap of a rare windmill needed serious attention as the coating and protective material had degraded from the twin Larch skin. It was of paramount importance to rescue the windmill from any further trauma as it is the last stone bodied, 6 sail working windmill in the Country. The Cap and fan tail needed serious protection following repairs to the larch substrate as part of a refurbishment to this iconic working windmill

Close up of the condition of the cap, prior to restoration works

The old coatings and protective materials were removed and any necessary repairs were made to the Larch Substrate.. Belzona 3921 (GSC Surface Conditioner) was used prior to the Belzona 3111 (Flexible Membrane), which was reinforced by a selection of Belzona 9311 (Reinforcement Sheet) and Belzona 9431 (Reinforcement Tape).

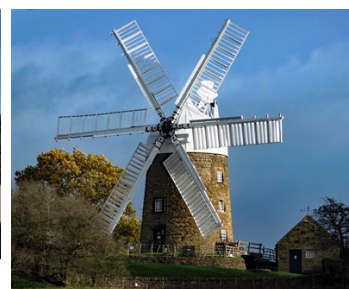
Back to its former glory

The Windmill now looks fantastic and is well protected against the elements, in the exposed hills of Southern Derbyshire
