# Belzona Saves Rare Windmill

**Industry:** Buildings & Structures  
**Application:** RPA-Roof Problem Areas  
**Substrate:** Other  
**Products:** Belzona 3111 (Flexible Membrane), Belzona 3921 (GSC Surface Conditioner)

**Customer Location:** Derbyshire  
**Application Date:** September 2023

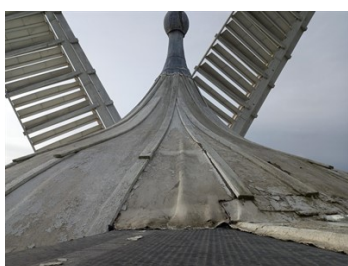
The cap of a rare windmill needed serious attention as the coating and protective material had degraded from the twin Larch skin. It was of paramount importance to rescue the windmill from any further trauma as it is the last stone bodied, 6 sail working windmill in the Country. The Cap and fan tail needed serious protection following repairs to the larch substrate as part of a refurbishment to this iconic working windmill

Close up of the condition of the cap, prior to restoration works

The old coatings and protective materials were removed and any necessary repairs were made to the Larch Substrate.. Belzona 3921 (GSC Surface Conditioner) was used prior to the Belzona 3111 (Flexible Membrane), which was reinforced by a selection of Belzona 9311 (Reinforcement Sheet) and Belzona 9431 (Reinforcement Tape).

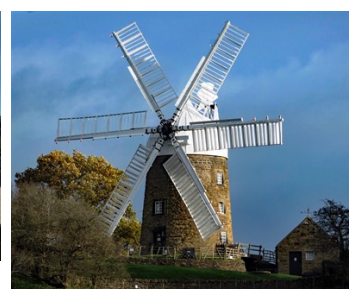
Back to its former glory

The Windmill now looks fantastic and is well protected against the elements, in the exposed hills of Southern Derbyshire
