# Belzona chosen for Rope Access repairs to huge concrete chimney

ID: 9175

Application: WPA-Wall Problem Areas

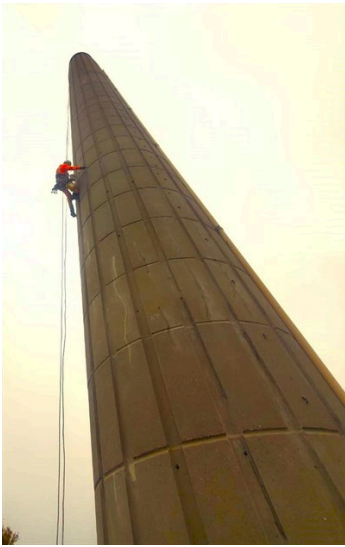
Spalling concrete was identified on a 300' concrete chimney during a rope access inspection. The concrete was unstable in certain areas and the Rope Access company's report highlighted numerous repair areas to make the structure safe and prevent falling debris from height

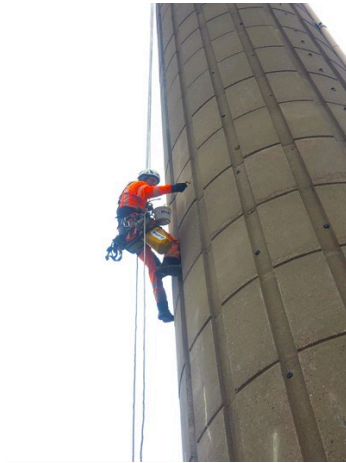
The work and scope made this impossible to shutter or to scaffold

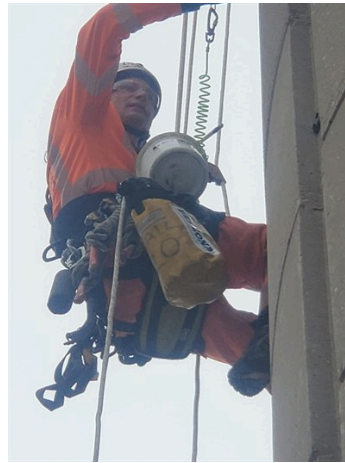
Rope access and a lightweight repair polymer was the most preferential choice due to access difficulties

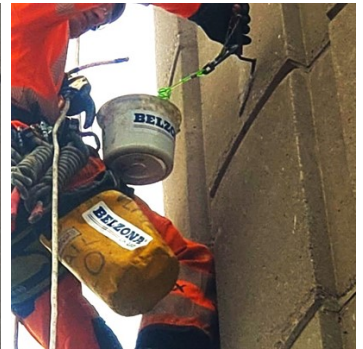
Completing the works

A rope access company who have worked with us many times, safely completing this difficult work
