Belzona chosen for Rope Access repairs to huge concrete chimney

Application: WPA-Wall Problem Areas

Substrate: Concrete

Products: Belzona 4141 (Magma-Build), Belzona 4911 (Magma TX Conditioner)

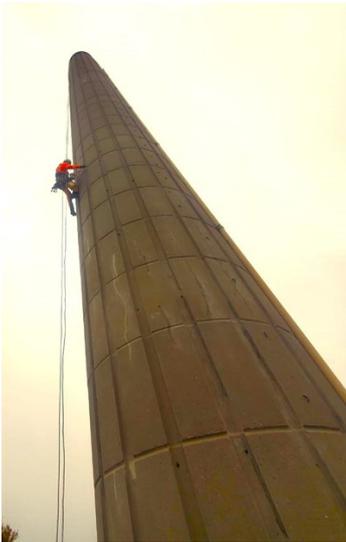
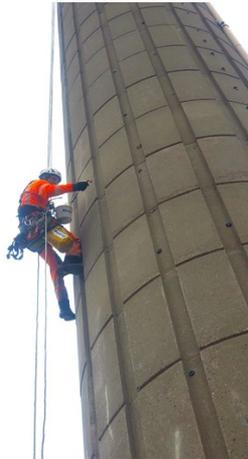
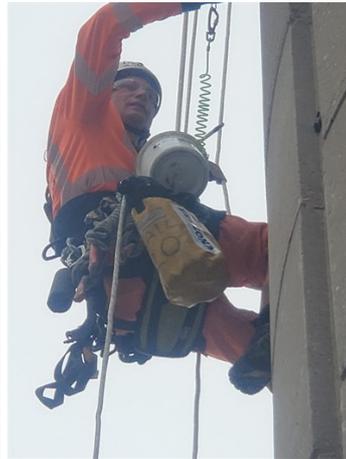
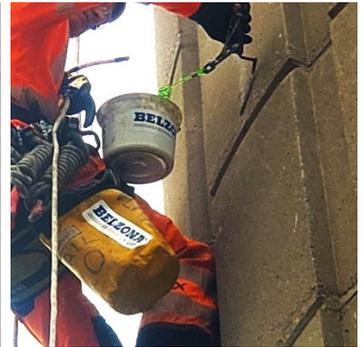
The work and scope made this impossible to shutter or to scaffold

Rope access and a lightweight repair polymer was the most preferential choice due to access difficulties

A rope access company who have worked with us many times, safely completing this difficult work
