# Belzona Trials New SF6 Leak Solution to Seal the Deal.

**Industry:** Power  
**Application:** VPF-Valves, Pipes and Fittings  
**Substrate:** Aluminum  
**Products:** Belzona 1981 (SuperWrap II), Belzona 7311

**Customer Location:** North East, United Kingdom  
**Application Date:** September 2023

Electric Switch Gear flange within a Power Distribution Substation.

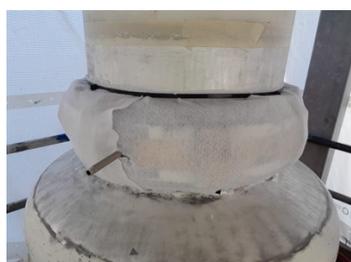
SF6 flange following surface preparation to SSPC-SP11, installation of the Backing Rod, tape, Redirection Nozzle & Breather Membrane.

The substrate (Aluminium) was first prepared in accordance with SSPC-SP11 Surface Preparation using an MBX (using a Stainless Steel wheel to prevent bi-metallic contamination). Once prepared, a backing-rod was applied behind the flange bolts and tape was applied over the bolts themselves (this prevents Belzona from adhering to them and allows a smoother surface transition). A Breather Membrane was applied around the circumference of the flange encapsulating it in its entirety, a Redirection Nozzle was also fitted to channel the leaking gas. Belzona 7311 was then applied to seal the membrane prior to the application of the impregnated Belzona 9341 (Reinforcement Sheet). The newly applied Belzona 7311 was then wetted out using Belzona 1981 (Winter Grade) SWII Resin prior to the application of 5 x wraps of Belzona 9371 (SWI Reinforcement Sheet) forming 10-layers (due to the 50% overlap). This was then left to polymerise (generating a slight self-curing exotherm) prior to a final encapsulating layer of Belzona 7311. The application required approximately 6L of Belzona 7311 & 5L of Belzona 1981. The application was carried out in accordance with a modified version of Belzona System Leaflet VPF-12.

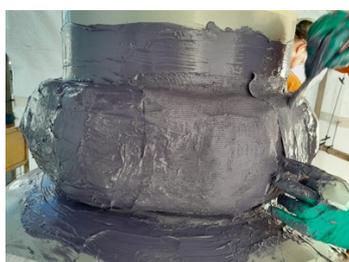
Wetting out of the Breather Membrane and vertical application of Reinforcement Sheets (Belzona 9341) using Belzona 7311.

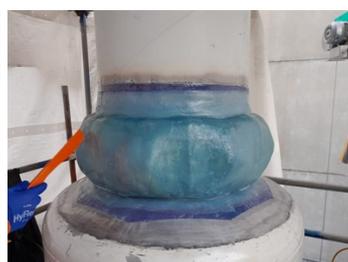
Post-application of 5x wraps of reinforcement sheet (Belzona 9371) and Belzona 1981 resin.

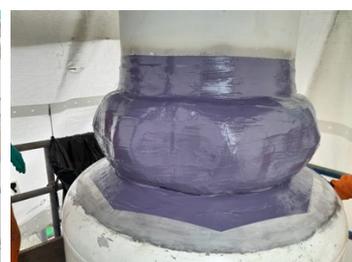
Final application after a further encapsulating layer of Belzona 7311.

Belzona conducted this application on a trial basis and had a remit to reduce the leak by at least a minimum of 80%. The application was undertaken within a 12-hour shift. The solution was classed as successful after 3-months of service and is now being rolled out
