Belzona protects operatives from heat exposure with thermal insulation solution for Fortune 500 Oil and Gas company

ID: 9180

Industry: Oil & Gas
Application: TCC-Tanks and Chemical Containment Areas
Substrate: Carbon steel
Products: Belzona 1121 (Super XL-Metal), Belzona 5871

Thermal insulation for a tank at a lubricant plant.

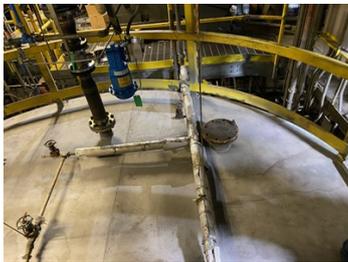
A tank which reaches a temperature of 110 °C (230 °F) and serves as a walkway for operators required thermal insulation in order to aid health and safety standards. According to the guidance set forth by the Occupational Safety and Health Administration (OSHA), the maximum temperature for exposed surfaces that an employee could come into contact with is 60 °C (140 °F), in line with ASTM C1055. Workers must be protected from exposed heated surfaces, so it was crucial to lower the surface temperature of this tank to eliminate this hazard. Additionally, some pitting corrosion had occurred.

Unprotected tank's upper surface, operating at high temperatures.

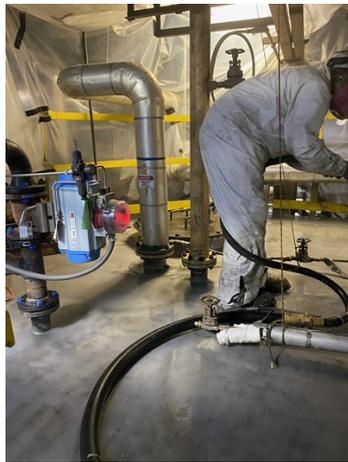
Surface preparation before application

Prior to coating the vessel was vapour blasted to meet SSPC-SP10 (Near-White Metal) standards and was then degreased. Additionally, some corrosion on the top of the tank required pit filling with Belzona 1121 (Super XL-Metal) ahead of the coating being applied. With the surface prepared, the first coat of Belzona 5871 was then applied using a short-bristled brush. This product expands, reducing the number of layers which are needed, the first coat was applied at the target thickness of 1000 µm (39 mil) wet film thickness, which results in 3000 µm (118 mil) dry film thickness. The second coat was then applied using the same method six hours later. The tank was back to full service just 12 hours after the final coat was applied.

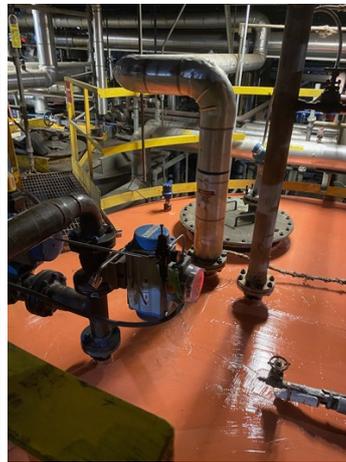
Tank top after one coat of Belzona 5871.

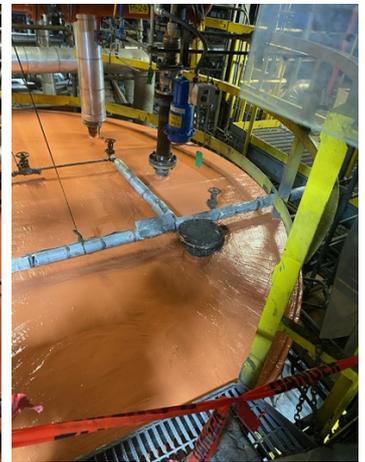
Finished application of Belzona 5871

The application is performing well. The customer has been satisfied with the outcome, but it has only been in service for less than 2 months.
