Belzona protects operatives from heat exposure with thermal insulation solution for Fortune 500 Oil and Gas company

ID: 9180

Industry: Oil & Gas
Application: TCC-Tanks and Chemical Containment Areas
Substrate: Carbon steel
Products: Belzona 1121 (Super XL-Metal), Belzona 5871

Thermal insulation for a tank at a lubricant plant.

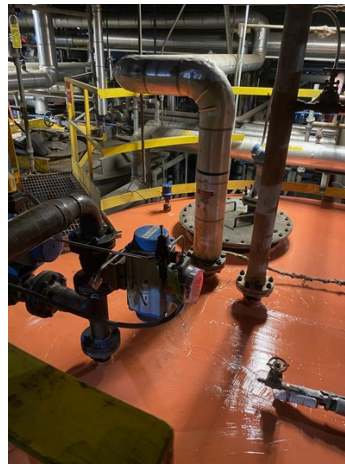
Tank top after one coat of Belzona 5871.

Prior to coating the vessel was vapour blasted to meet SSPC-SP10 (Near-White Metal) standards and was then degreased. Additionally, some corrosion on the top of the tank required pit filling with Belzona 1121 (Super XL-Metal) ahead of the coating being applied. With the surface prepared, the first coat of Belzona 5871 was then applied using a short-bristled brush. This product expands, reducing the number of layers which are needed, the first coat was applied at the target thickness of 1000 µm (39 mil) wet film thickness, which results in 3000 µm (118 mil) dry film thickness. The second coat was then applied using the same method six hours later. The tank was back to full service just 12 hours after the final coat was applied.

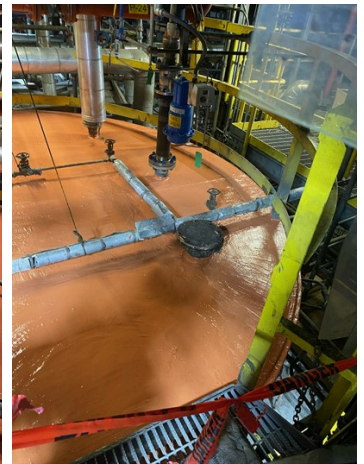
Finished application of Belzona 5871

The application is performing well. The customer has been satisfied with the outcome, but it has only been in service for less than 2 months.
