Belzona 4111 Repairs the Floor Drain

ID: 9181

Industry: *General Industry* Customer Location: *Tulsa Oklahoma*
Application: *FPA-Floor Problem Areas* Application Date: *December 2023*
Substrate: *Concrete*
Products: *Belzona 4111 (Magma-Quartz), Belzona 4911 (Magma TX Conditioner)*

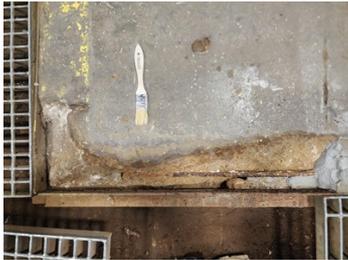
Damaged concrete at the edge of a floor drain trough.

The damaged area had been repaired with another material which was not bonded to the concrete, which resulted in an additional tripping hazard as it was now raised up. This is a water test area for large vessels and requires a smooth floor to roll carts over and sees a lot of foot traffic as well. An uneven floor in this area poses a huge danger to both employees and equipment.

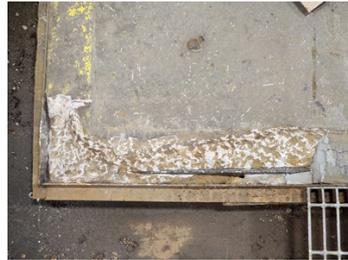
Previous failed repair material removed.

The previous repair material was removed in large pieces with a screwdriver as it was not bonded to the concrete. A wire wheel on a drill was used to remove all of the loose concrete debris. A 4" hand grinder with a stone grinding wheel was used to remove the rust from the metal frame and exposed rebar, as well as to remove as much of the surface of the concrete as possible. The Belzona 4911 Conditioner was liberally applied ensuring that the full area of application was fully coated into the uneven surface. The Belzona 4111 was mixed following the Instructions For Use and packed in by hand to ensure there were no air pockets or voids, and then finished using a steel concrete trowel.

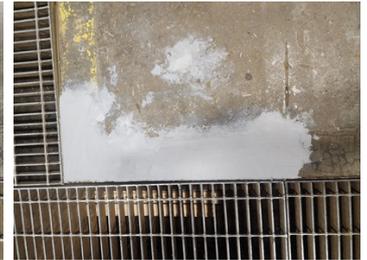
Belzona 4911 Conditioner applied liberally.
