# Plate bonding in marine bulkhead

ID: 9185

Industry: *Marine*  
Application: *TCC-Tanks and Chemical Containment Areas*  
Substrate: *Carbon steel*  
Products: *Belzona 1111 (Super Metal)*

Customer Location: *Scotland*  
Application Date: *March 2020*

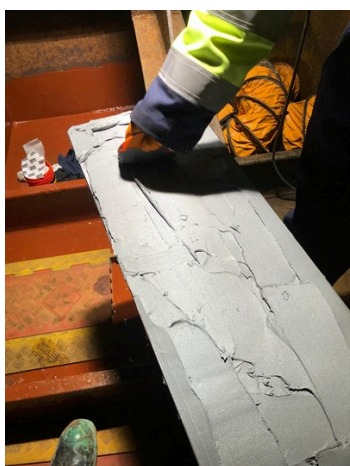
Belzona 1111 applied to plate

The area was prepared with an MBX Bristle blaster. Belzona 1111 was then used to wet out the substrate & the plate. The plate was then pushed into position to reinforce the corroded area.

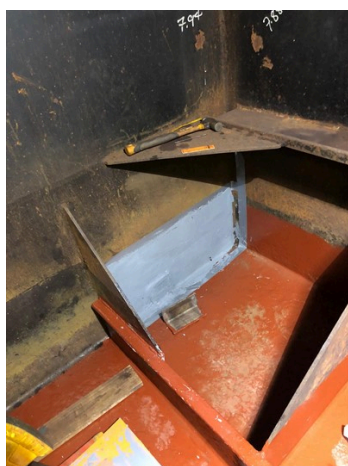
Substrate wet out

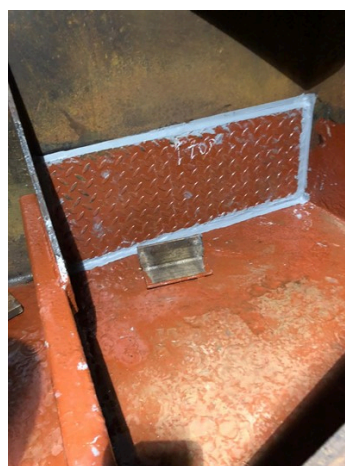
Plate applied to the corroded area
