Plate bonding in marine bulkhead

ID: 9185

Industry: *Marine*
Application: *TCC-Tanks and Chemical Containment Areas*
Substrate: *Carbon steel*
Products: *Belzona 1111 (Super Metal)*

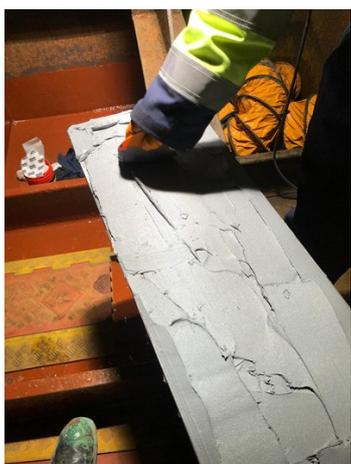
An area of corrosion had led to wall thinning on a bulkhead. Welding was undesirable due to the confined space & close proximity of fuel.

Belzona 1111 applied to plate

The area was prepared with an MBX Bristle blaster. Belzona 1111 was then used to wet out the substrate & the plate. The plate was then pushed into position to reinforce the corroded area.

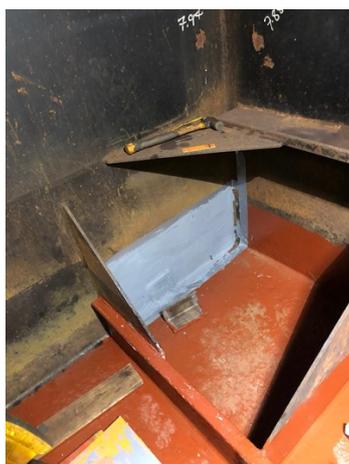
Substrate wet out

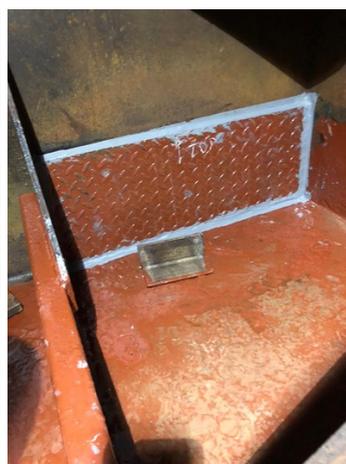
Plate applied to the corroded area
