Flange Face Reforming to Stop Leakage and Future Corrosion

ID: 9190

Industry: *Commercial Facilities*
 Application: *VPF-Valves, Pipes and Fittings*
 Substrate: *Carbon steel*
 Products: *Belzona 1111 (Super Metal)*

Customer Location: *Dammam*
 Application Date: *October 2022*

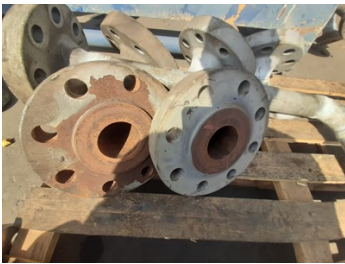
The flange faces were severely corroded and leaking.

Initial condition of flanges

Grit blasting with a surface profile of 75 microns and a cleanliness of Sa2.5. A former equal to the flange dimension was prepared. Belzona 9341 Release Agent was applied to the former and allowed to dry for some time. A layer of Belzona 1111 was applied to both the flange face and released former, then the paste grade material was built up across the flange face using a Belzona applicator cut to a V-shaped contour to form a high peak in the centre line. The flange and former were bolted together and left to cure according to the IFU. When the former was removed, the required serration pattern appeared on the flange face face, as requested by the customer.

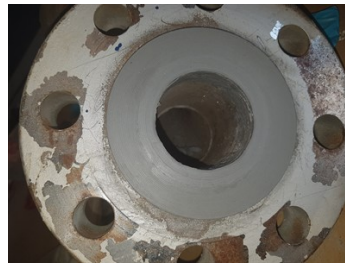
Flange faces rebuilt and restored using forming technique

Completed application
