# Flange Face Reforming to Stop Leakage and Future Corrosion

ID: 9190

Industry: Commercial Facilities  
 Application: VPF-Valves, Pipes and Fittings  
 Substrate: Carbon steel  
 Products: Belzona 1111 (Super Metal)

Customer Location: Dammam  
 Application Date: October 2022

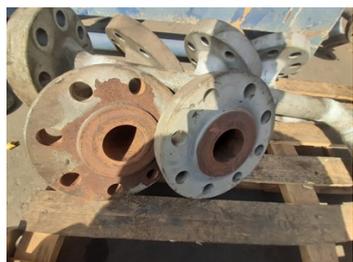
The flange faces were severely corroded and leaking.

Initial condition of flanges

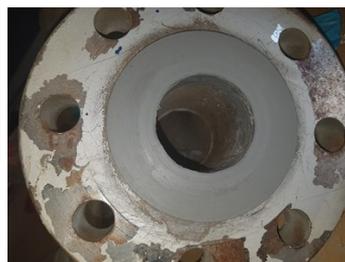
Flange faces rebuilt and restored using forming technique

Completed application

Grit blasting with a surface profile of 75 microns and a cleanliness of Sa2.5. A former equal to the flange dimension was prepared. Belzona 9411 Release Agent was applied to the former and allowed to dry for some time. A layer of Belzona 1111 was applied to both the flange face and released former, then the paste grade material was built up across the flange face using a Belzona applicator cut to a V-shaped contour to form a high peak in the centre line. The flange and former were bolted together and left to cure according to the IFU. When the former was removed, the required serration pattern appeared on the flange face face, as requested by the customer.
