# Repair and Protection of Inter Stage Chiller Tubesheet

ID: 9191

Application: HEX-Heat Exchangers

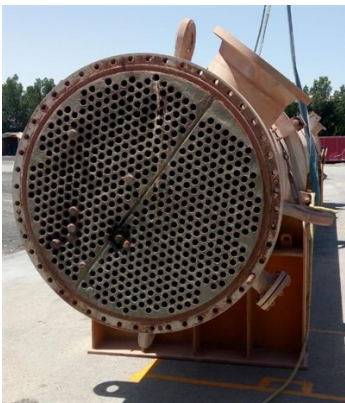
Tubesheet suffering from galvanic corrosion. Erosive damage at the division bar was observed; severe erosion due to the slurry medium.

Initial condition of the tubesheet

Hydro-jet cleaning was conducted first. Wooden plugs were inserted in all tubes to protect against high speed abrasives. A surface profile of 75 microns and a cleanliness of Sa2.5 were achieved. Rebuilt using Belzona 1311 paste grade and protected the tubesheet using Belzona 1392 coating grade. The repair and coating work was carried out in accordance with the Belzona System Leaflets HEX-1 and HEX-3.

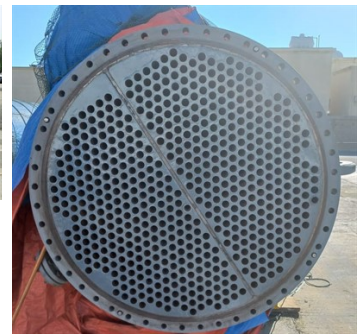
Completed application
