Repair and Protection of Inter Stage Chiller Tubesheet

Application: HEX-Heat Exchangers

Substrate: Carbon steel

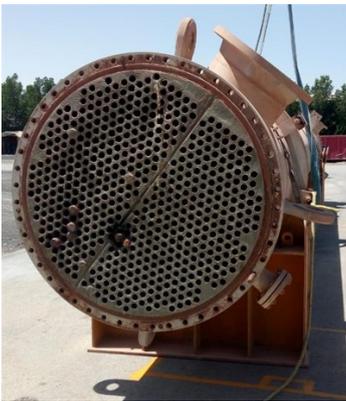
Tubesheet suffering from galvanic corrosion. Erosive damage at the division bar was observed; severe erosion due to the slurry medium.

Initial condition of the tubesheet

Hydro-jet cleaning was conducted first. Wooden plugs were inserted in all tubes to protect against high speed abrasives. A surface profile of 75 microns and a cleanliness of Sa2.5 were achieved. Rebuilt using Belzona 1311 paste grade and protected the tubesheet using Belzona 1392 coating grade. The repair and coating work was carried out in accordance with the Belzona System Leaflets HEX-1 and HEX-3.

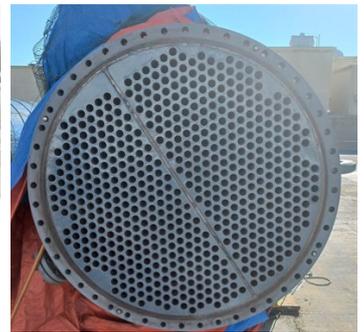
Completed application
