Protection of Pump Impeller from Seawater Service

ID: 9192

Industry: Oil & Gas
Application: CEP-Centrifugal Pumps
Substrate: Carbon steel
Products: Belzona 1341 (Supermetalgilde)

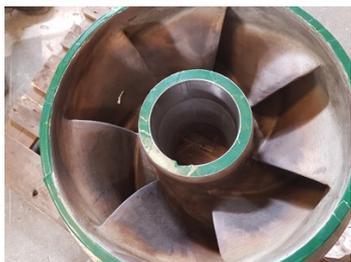
The impeller was exposed to corrosion due to unfiltered seawater as the pump medium. The customer needed a coating that could prevent corrosion and increase pump efficiency.

Before application

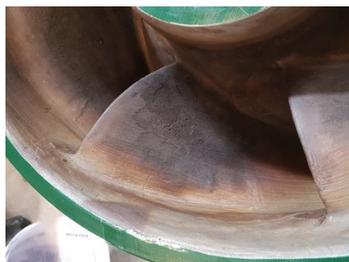
Close up of impeller vanes

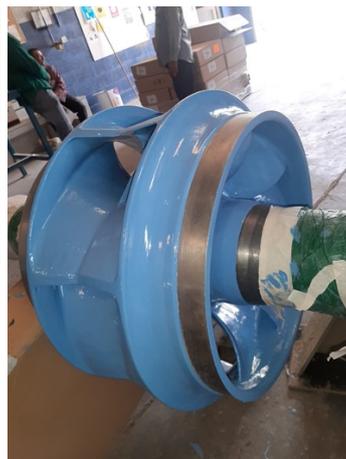
Fully coated impeller for protection

Grit blasting with a surface profile of 75 microns and a cleanliness of Sa2.5. Application was carried out in accordance with Belzona Know-How System Leaflet CEP-3 with two coats of Belzona 1341 according to the IFU.

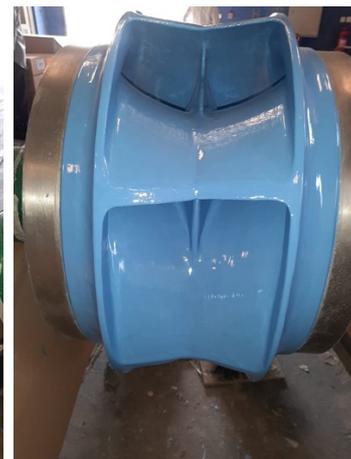
Another angle for completed application
