Protection of Pump Impeller from Seawater Service

ID: 9192

Industry: Oil & Gas
Application: CEP-Centrifugal Pumps
Substrate: Carbon steel
Products: Belzona 1341 (Supermetalgilde)

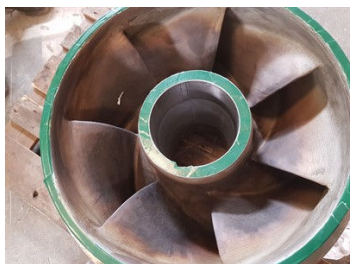
The impeller was exposed to corrosion due to unfiltered seawater as the pump medium. The customer needed a coating that could prevent corrosion and increase pump efficiency.

Before application

Grit blasting with a surface profile of 75 microns and a cleanliness of Sa2.5. Application was carried out in accordance with Belzona Know-How System Leaflet CEP-3 with two coats of Belzona 1341 according to the IFU.

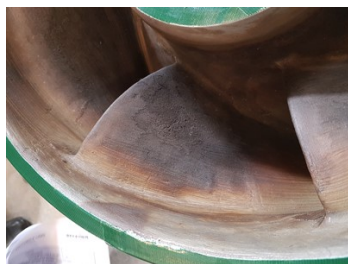
Close up of impeller vanes

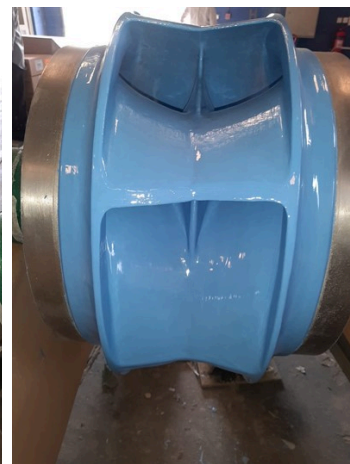
Another angle for completed application
