Belzona Repairs and Protects a Split Casing Pump

ID: 9193

Industry: Oil & Gas
Application: CEP-Centrifugal Pumps
Substrate: Carbon steel
Products: Belzona 1111 (Super Metal), Belzona 1341 (Supermetalgilde)

Customer Location: Al Khaffi
Application Date: May 2022

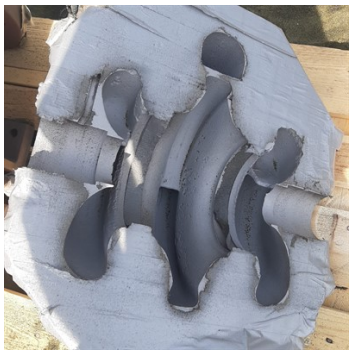
The customer noticed small cavities in the casing due to pitting corrosion during inspection and were concerned about the life of the equipment as this could lead to failure.

Grit blasted casing

Application was carried out in accordance with Belzona Know-How System Leaflets CEP-3, CEP-5 and CEP-10. Belzona 1111 was applied to the pitted area and the casing was further protected with two coats of Belzona 1341.

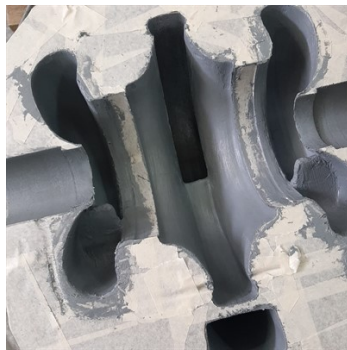
Pit filling and rebuilding application prior to coating

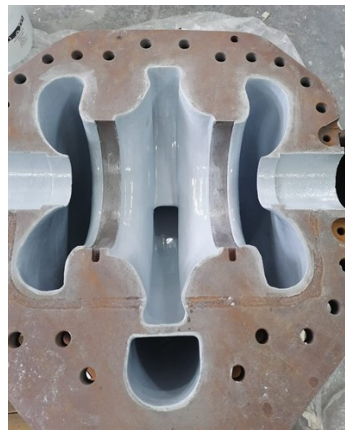
Coated and protected casing interior
