# Belzona protects bunds against high strength acids

ID: 9194

**Industry:** General Industry  
**Application:** TCC-Tanks and Chemical Containment Areas  
**Substrate:** Concrete  
**Products:** Belzona 4311 (Magma CR1), Belzona 4911 (Magma TX Conditioner)

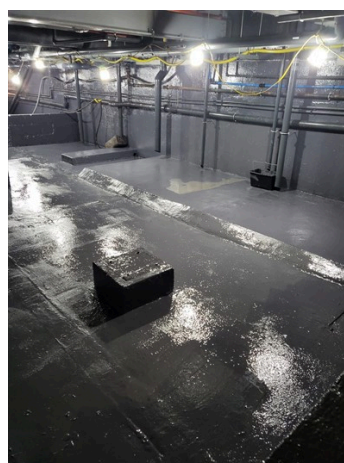
Acids were leaking into the bund at several entry points. These were breaking down the existing coating & leading to damage in the concrete substrate.

Corroded bund

The area was prepared by washing down & mechanical abrasion. Belzona 4911 was then applied followed by two coats of Belzona 4311 CR1.
