BELZONA PROTECTS PULSATION DAMPENER

Industry: *Chemical & Petrochemical*
Application: *VPF-Valves, Pipes and Fittings*
Substrate: *Carbon steel*
Products: ** Belzona® 1391 ,*

Customer Location: *Offshore drilling company*
Application Date: *1994*

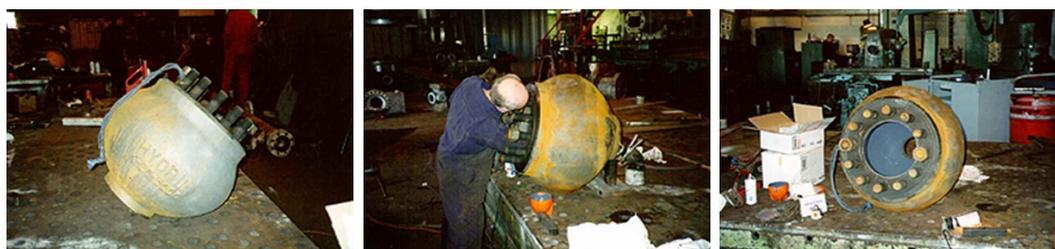
Photograph Descriptions

The rough surface caused by corrosion within the dampener was causing the diaphragm to be holed very quickly. This was leading to the drilling operation having to be shut down whilst the diaphragm was changed.

- * The unit after surface preparation which involved repeated washing and grit blasting to remove salt contamination ,
- * Application of Belzona® 1391 underway ,
- * The completed application. The smooth corrosion resistant surface will minimise wear on the diaphragm ,

Pulsation dampeners handling a mixture of brine and drilling mud at temperature of 100°C and 350 bar pressure.

Application was carried out in accordance with Belzona System Leaflet VPF-2.
