# BELZONA SEALS HOLES IN SPRINKLER TANK

Customer Location: Municipal Waste Collection Facility,  
Manchester - UK

Products: Belzona® 1111 (Super Metal)

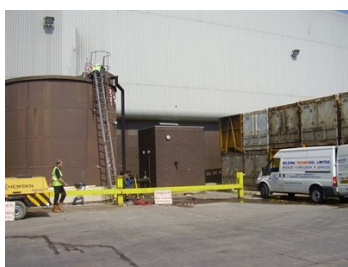
\* External view of tank , \* Water escaping through a hole in the tank , \* View of prepared substrate , \* Mild steel plates bonded to tank ,

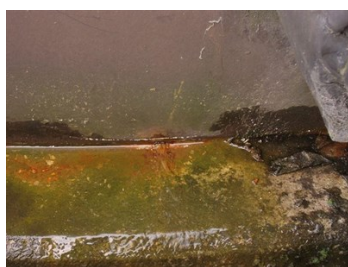
The tank was suffering from corrosion which had affected the wall thickness of the tank. In several areas this had caused holes in the tank which were now leaking. As this tank was a storage tank for water to be used for fire fighting it had to be structurally intact.
