# Belzona Quickly Coats and Protects Asphalt Shingle Color Process Cone/Silo

ID: 9204

Industry: Mining & Quarrying  
Application: SHM-Solids Handling Machinery

Customer Location: Norwood, MA  
Application Date: November 2023

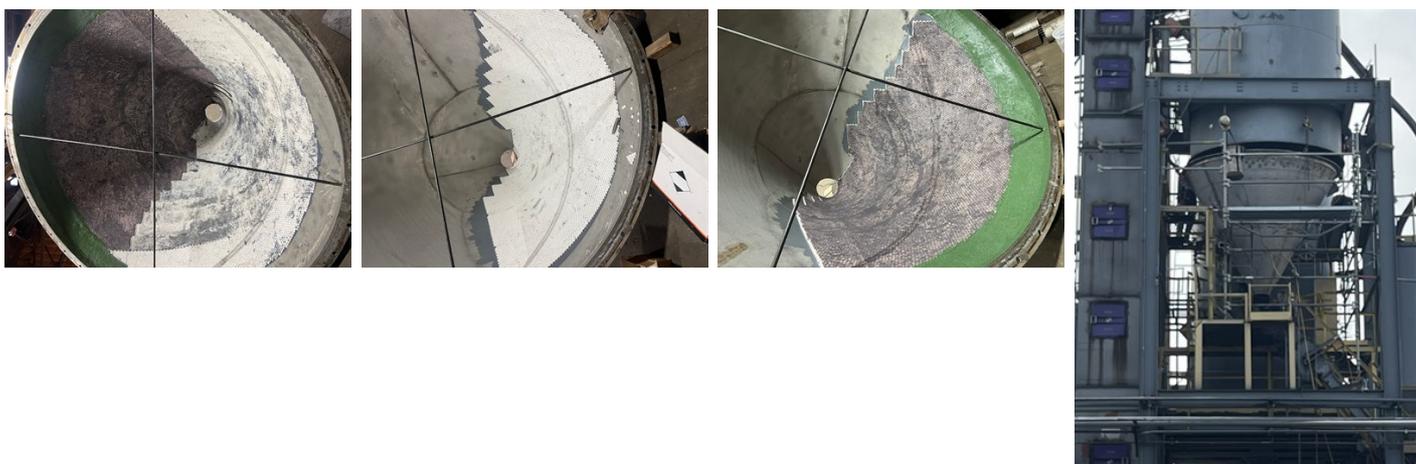
Old Silo had expired with countless holes. Addressed with makeshift patches, emitting product into the air. The customer was looking for a long term abrasion resistant solution.

Customer was looking for a long term solution for a brand new silo cone. The old cone had endured countless damages due to abrasion/erosion. Belzona was critical due to limited time frame during a plant shutdown.

Blasting took one day, and coating/application of Belzona 1321 (Ceramic S-Metal), bonding the Belzona 9811 Alumina Tiles, and grouting with 1814/1813 over the next two days resulting in a three day application process. The Cone is 255 sq ft. It was installed during a plant shutdown days later.
