Belzona Quickly Coats and Protects Asphalt Shingle Color Process Cone/Silo

ID: 9204

Industry: Mining & Quarrying
Application: SHM-Solids Handling Machinery

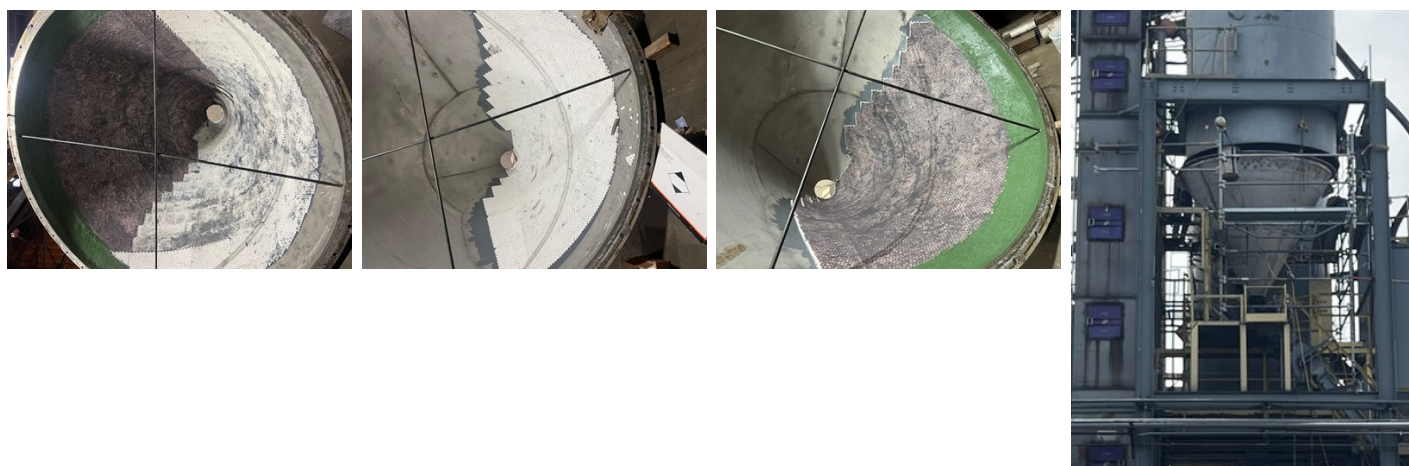
Old Silo had expired with countless holes. Addressed with makeshift patches, emitting product into the air. The customer was looking for a long term abrasion resistant solution.

Customer was looking for a long term solution for a brand new silo cone. The old cone had endured countless damages due to abrasion/erosion. Belzona was critical due to limited time frame during a plant shutdown.

Blasting took one day, and coating/application of Belzona 1321 (Ceramic S-Metal), bonding the Belzona 9811 Alumina Tiles, and grouting with 1814/1813 over the next two days resulting in a three day application process. The Cone is 255 sq ft. It was installed during a plant shutdown days later.
