TANK BASE SEALING WITH BELZONA

ID: 921

108m diameter oil storage tank

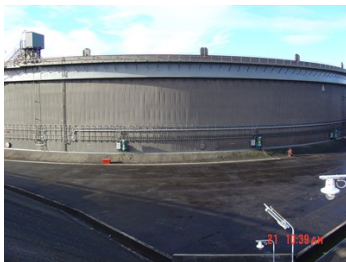
Water was penetrating under the annular ring leading to a corrosion risk.

Before application

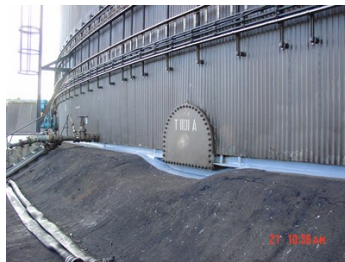
During application

Application was carried out in accordance with Belzona Know-How System Leaflet GSS-3. Damaged areas of the concrete base were repaired with Belzona 4131 prior to the full circumference of the base being sealed with a fully reinforced Belzona 3131 system.

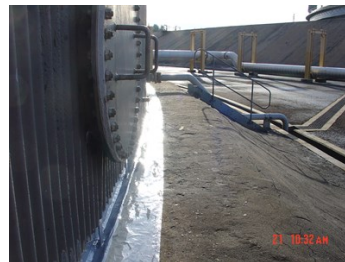
Belzona 3131 applied
