TANK BASE SEALING WITH BELZONA

ID: 921

Customer Location: Oil Production Company, North East Scotland

108m diameter oil storage tank

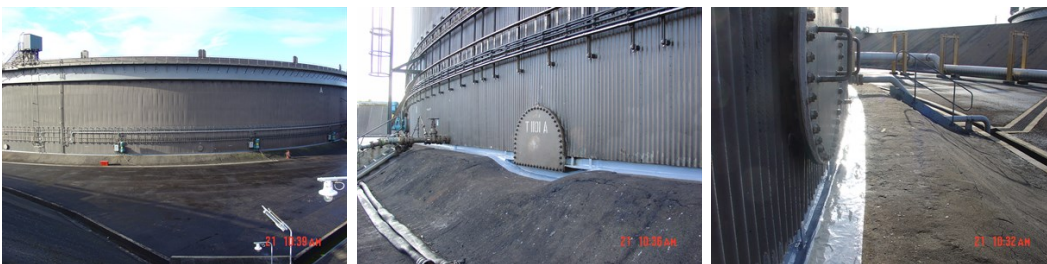
Photograph Descriptions

Water was penetrating under the anular ring leading to a corrosion risk.

- * The oil storage tank ,
- * Belzona® 3131 applied ,
- * Close view of Belzona® 3131 system ,
- * Belzona 3131 inspected in 2012 still in perfect condtion ,

Application was carried out in accordance with Belzona Know-How System Leaflet GSS-3. Damaged areas of the concrete base were repaired with Belzona® 4131 prior to the full circumference of the base being sealed with a fully reinforced Belzona® 3131 system.

The original plan was to inject a silicon type sealer around the tank base or a bitumastic coating but these were known to only offer temporary seal. The Belzona tank baser sealing system has a proven track record and this tank was found to be in perfect condition when inspexcted in 2012.
