Dryer Box - Belzona 1813

ID: 9210

Industry: *Chemical & Petrochemical*
Application: *SHM-Solids Handling Machinery*

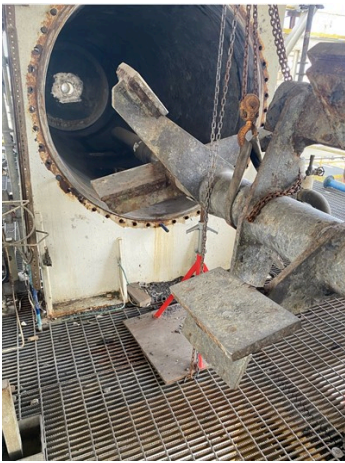
Dryer Box unit prior to abrasive blasting.

The unit was abarasive blasted to SSPC-SP10 with a minimum 3 mil dense and angular profile. The Belzona 1813 was applied with plastic applicators and trowels.

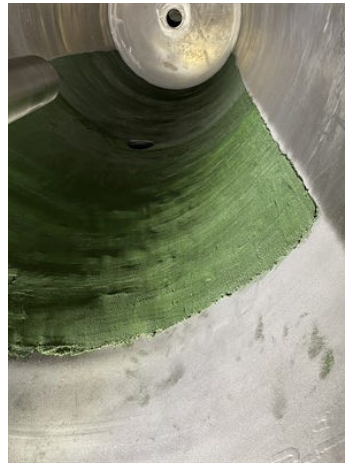
Application to the belly of the Dryer Box unit.

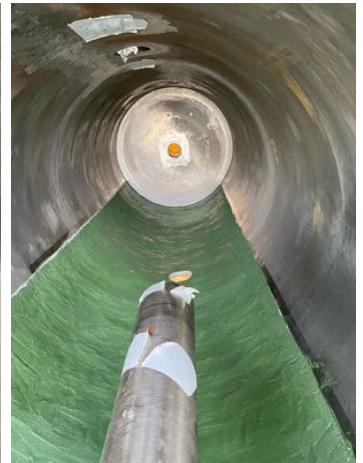
Finished application of the Belzona 1813. This was allowed to fully cure prior to placing in service.
