Stewart & Stevenson - Bellhousing Repair

ID: 9225

Industry: Transport
Application: ENC-Engines and Casings
Substrate: Aluminum
Products: Belzona 1161 (Super UW-Metal), Belzona 9111 (Cleaner Degreaser)

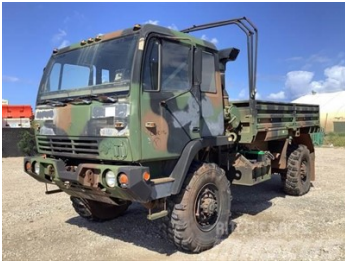
Stewart & Stevenson M1078
LMTV

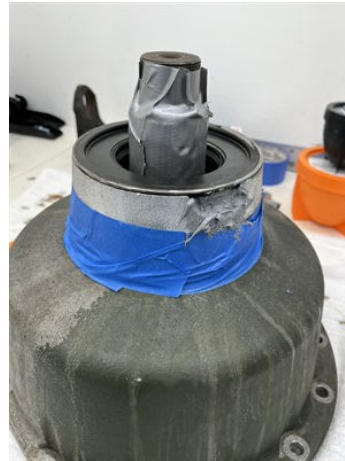
The original seal was inserted and used as former to fill the damaged site. This will cast a wall for the new seal to properly preform.

The repair was conducted using a customized approach based on Belzona System Leaflet ENC-01. Debris and grease were eliminated, and the surface was prepared using the MBX Bristle Blaster, followed by cleaning with Belzona 9111. The oil seal served as a former to fill the missing section of the bellhousing with Belzona 1161. Lastly, the repair was finalized by applying Belzona 9341 wrap impregnated with Belzona 1161 around the bellhousing.

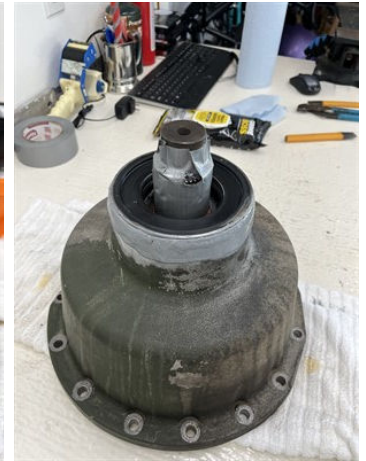
A final wrap was done to create hoop strength, ensuring that any impacts, vibration or movement will not compromise the repair.
