Stewart & Stevenson - Bellhousing Repair

Application: ENC-Engines and Casings

Stewart & Stevenson M1078
LMTV

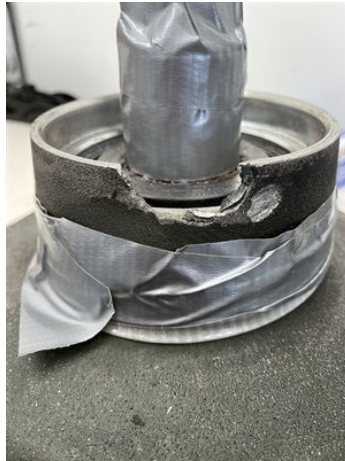
Due to inadequate maintenance; a sudden and unexpected disassembly of the universal joint and driveshaft occurred, causing significant damage to a portion of the transfer case bellhousing and affecting the performance of the oil seal.

Are that broken driveshaft and u-joint impacted the case. This are is where the seal is installed.
