Stewart & Stevenson - Bellhousing Repair

ID: 9225

Application: ENC-Engines and Casings

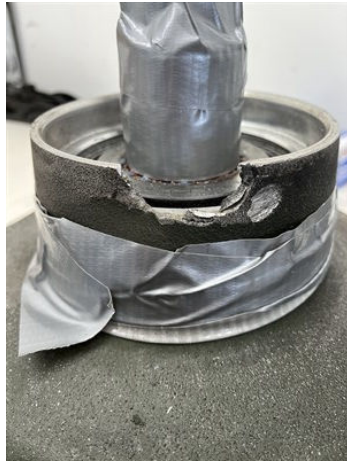
Due to inadequate maintenance; a sudden and unexpected disassembly of the universal joint and driveshaft occurred, causing significant damage to a portion of the transfer case bellhousing and affecting the performance of the oil seal.

Are that broken driveshaft and u-joint impacted the case. This are is where the seal is installed.
