Stewart & Stevenson - Bellhousing Repair

Application: ENC-Engines and Casings

Stewart & Stevenson M1078 LMTV

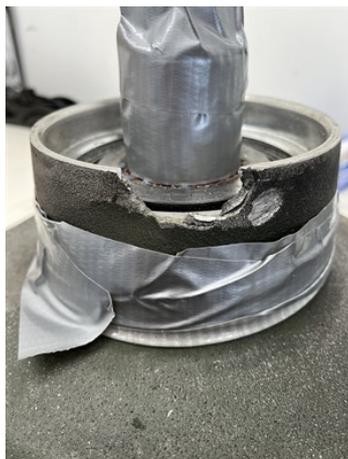
Due to inadequate maintenance; a sudden and unexpected disassembly of the universal joint and driveshaft occurred, causing significant damage to a portion of the transfer case bellhousing and affecting the performance of the oil seal.

Are that broken driveshaft and u-joint impacted the case. This are is where the seal is installed.
