# Belzona Florida Repairs water Discharge Flange

Industry: Power  
Application: VPF-Valves, Pipes and Fittings  
Substrate: Concrete  
Products: Belzona 1111 (Super Metal), Belzona 1321 (Ceramic S-Metal)

Customer Location: Fort Lauderdale, Florida  
Application Date: December 2023

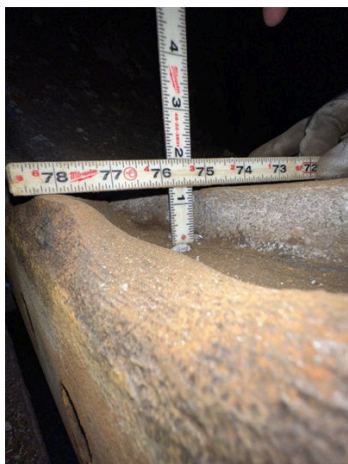
The customer had a non-Belzona coating previously applied that failed, causing corrosion scaling on the interior edge of the flange.

Showcasing and measuring the damage caused by the corrosion.

Removed corrosion scaling with pneumatic chipping guns and needle scalers. A high pressure grit blaster with 24 grit aluminum oxide was utilized to obtain a SSPC SP-10 level of cleanliness with a minimum surface profile of 3 mils. Keane-Tator Surface Profile Comparator grit was used to verify the surface profile. The area was then soaked with demineralized water and left to sit overnight to allow chlorides to leech out. Then it was brush blasted with 30 grit aluminum oxide back to SSPC SP-10.

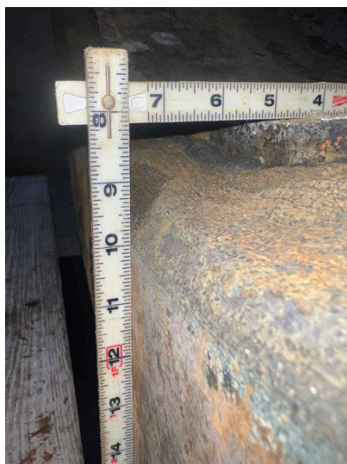
Showcasing and measuring the damage caused by the corrosion.

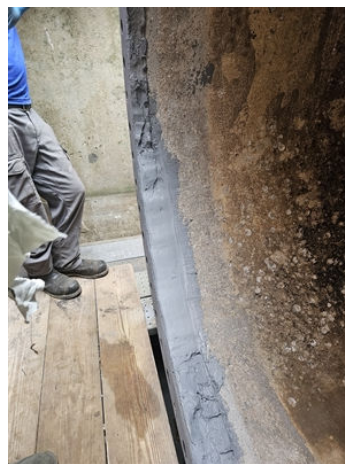
Rebuilding the damage using Belzona 1111.

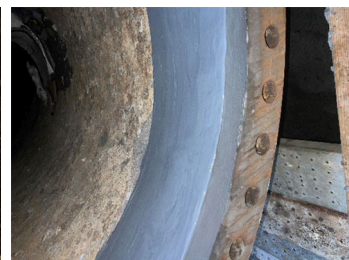
Application of Belzona 1321.
