Belzona Florida Repairs water Discharge Flange

ID: 9237

Industry: Power
Application: VPF-Valves, Pipes and Fittings
Substrate: Concrete
Products: Belzona 1111 (Super Metal), Belzona 1321 (Ceramic S-Metal)

Customer Location: Fort Lauderdale, Florida
Application Date: December 2023

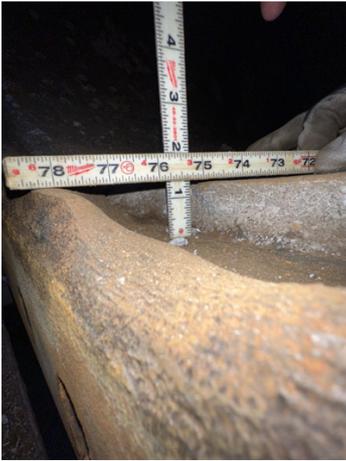
The customer had a non-Belzona coating previously applied that failed, causing corrosion scaling on the interior edge of the flange.

Showcasing and measuring the damage caused by the corrosion.

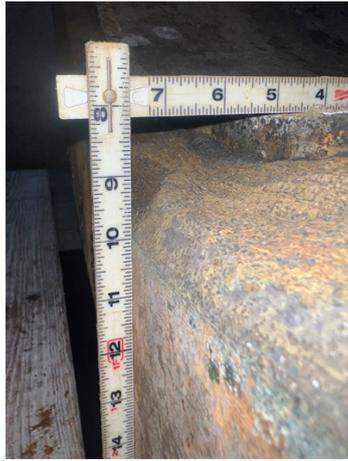
Showcasing and measuring the damage caused by the corrosion.

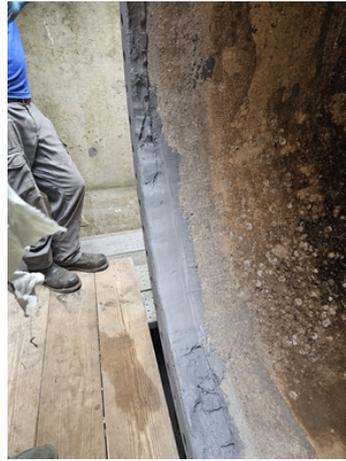
Rebuilding the damage using Belzona 1111.

Removed corrosion scaling with pneumatic chipping guns and needle scalers. A high pressure grit blaster with 24 grit aluminum oxide was utilized to obtain a SSPC SP-10 level of cleanliness with a minimum surface profile of 3 mils. Keane-Tator Surface Profile Comparator grit was used to verify the surface profile. The area was then soaked with demineralized water and left to sit overnight to allow chlorides to leech out. Then it was brush blasted with 30 grit aluminum oxide back to SSPC SP-10.

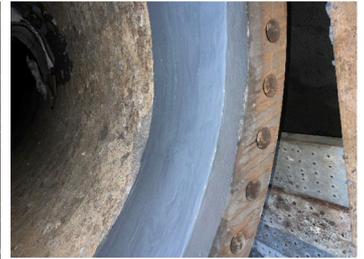
Application of Belzona 1321.
