# Rebuilding concrete columns in a colling tower.

ID: 9241

Industry: *Steel & Metal Processing*  
Application: *WPA-Wall Problem Areas*  
Substrate: *Concrete*  
Products: *Belzona 4141 (Magma-Build), Belzona 5811 (Immersion Grade)*

Customer Location: *Gary, Indiana*  
Application Date: *September 2023*

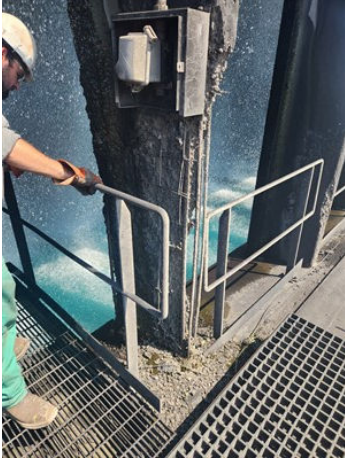
*The customer faced deteriorations of concrete columns with exposed rebars in their cooling tower.*

Deterioration of the columns

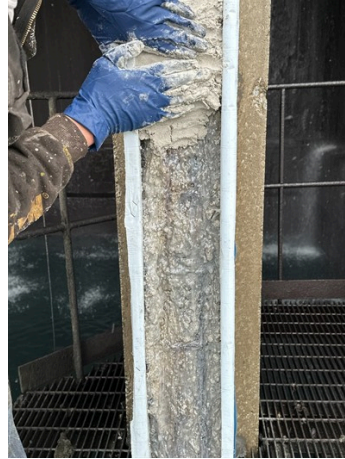
Application of Belzona 4141 for repair

Specific techniques, such as floats and a wood mold, were employed for the best finish. After curing, the product was sanded for an even better result.

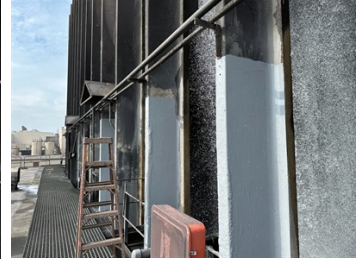
Application of Belzona 5811 for protection
