Rebuilding Concrete Columns in a Cooling Tower.

ID: 9241

Industry: Steel & Metal Processing
Application: WPA-Wall Problem Areas
Substrate: Concrete
Products: Belzona 4141 (Magma-Build), Belzona 5811 (Immersion Grade)

Customer Location: Gary, Indiana
Application Date: September 2023

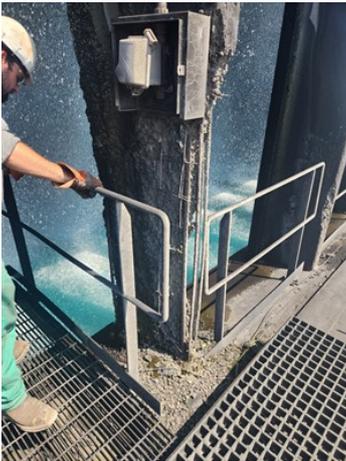
The customer faced deterioration of concrete columns within their cooling tower, resulting in exposed reinforcement bars. This type of damage can accelerate corrosion, weaken structural integrity, and increase the risk of further deterioration if left unaddressed.

Deterioration of the columns

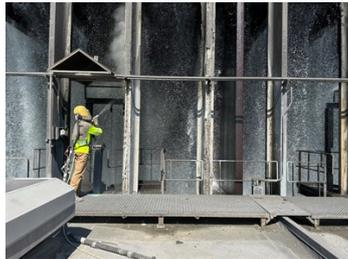
Surface preparation on concrete

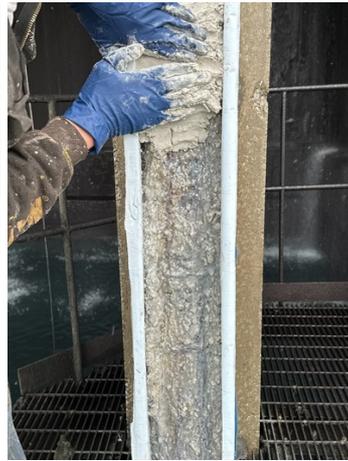
Application of Belzona 4141 for repair

Specific techniques, such as floats and a wood mold, were employed for the best finish. After curing, the product was sanded for an even better result.

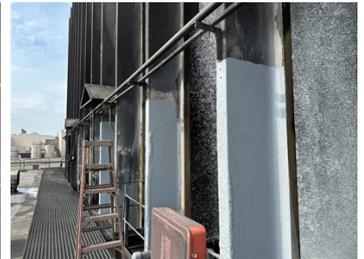
Application of Belzona 5811 for protection
