# Linde Intercooler Repair

ID: 9242

Application: HEX-Heat Exchangers

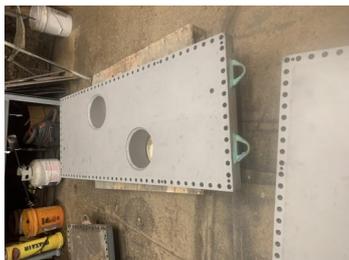
Intercooler tube sheet and end covers had corrosion due to b-metallic corrosion.

Before application

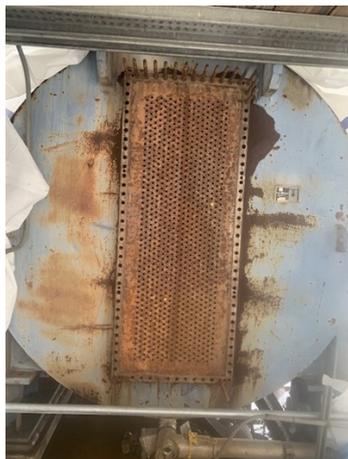
Overview of application area

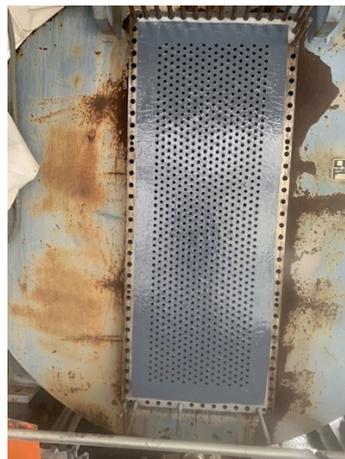
Final application

The application was carried out in accordance with Belzona Know-How System Leaflet HEX-1 for repairing eroded-corroded tube sheets. The surface was prepared by grit blasting and the surface was washed with Belzona 9111. The tubes were plugged with rubber stoppers and Belzona 1111. The second coat of Belzona 1321 was applied in accordance with Belzona Instructions for Use.
