Linde Intercooler Repair

Application: HEX-Heat Exchangers

Products: Belzona 1111 (Super Metal), Belzona 1321 (Ceramic S-Metal)

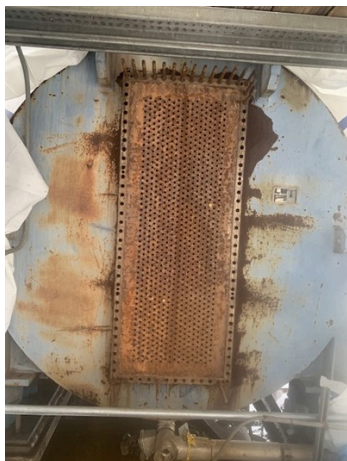
Overview of application area

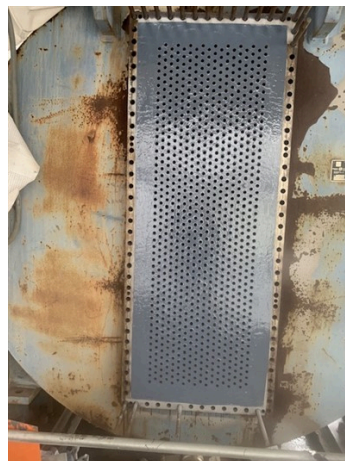
Final application

The application was carried out in accordance with Belzona Know-How System Leaflet HEX-1 for repairing eroded-corroded tube sheets. The surface was prepared by grit blasting and the surface was washed with Belzona 9111. The tubes were plugged with rubber stoppers and Belzona 1111. The second coat of Belzona 1321 was applied in accordance with Belzona Instructions for Use.
