Belzona repairs & protects a process gas knock out drum in a steel manufacturing plant

ID: 9246

Industry: *Steel & Metal Processing*
Application: *TCC-Tanks and Chemical Containment Areas*
Substrate: *Carbon steel*
Products: *Belzona 1391T*

Customer Location: *Elsokhna , Egypt*
Application Date: *June 2022*

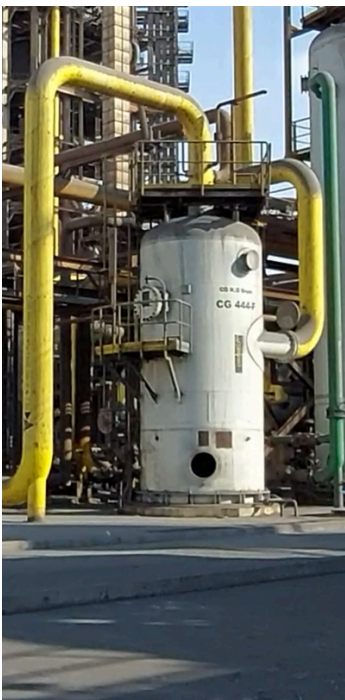
General view of the vessel

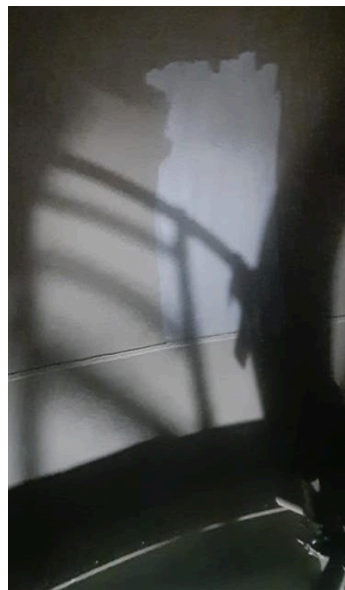
Corrosion & pitting detected in the vessel' s internal surface of the process gas KO drum.

The internal surface before application

Rebuilding the surface after grit blasting.

Application was carried out in accordance with Belzona Know-How System Leaflet TCC-5 , the surface was grit blasted , the surface was cleaned. All the pitted areas then were rebuilt & Belzona 1391T was applied to the drum.

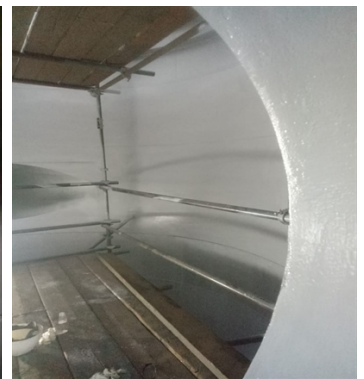
Applying 2 coats of Belzona 1391T
