# Belzona repairs & protects a process gas knock out drum in a steel manufacturing plant

ID: 9246

Customer Location: *Elsokhna , Egypt*  
Application Date: *June 2022*

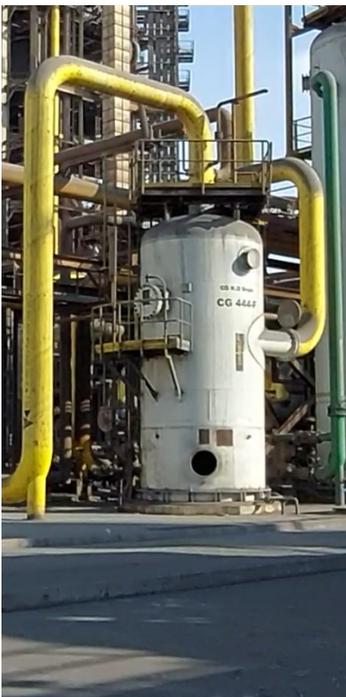
General view of the vessel

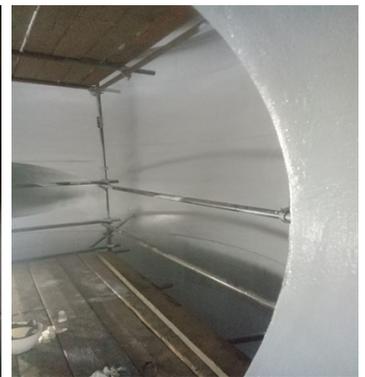
Applying 2 coats of Belzona 1391T

Application was carried out in accordance with Belzona Know-How System Leaflet TCC-5 , the surface was grit blasted , the surface was cleaned. All the pitted areas then were rebuilt & Belzona 1391T was applied to the drum.
