# Belzona repairs & protects a process gas knock out drum in a steel manufacturing plant

ID: 9246

Customer Location: *Elsokhna , Egypt*  
Application Date: *June 2022*

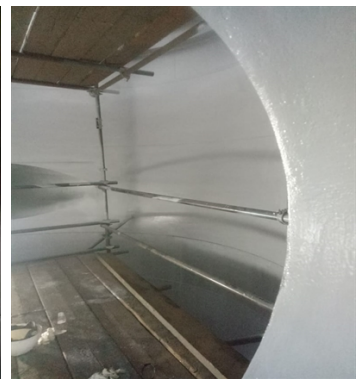
Applying 2 coats of Belzona 1391T

Application was carried out in accordance with Belzona Know-How System Leaflet TCC-5 , the surface was grit blasted , the surface was cleaned. All the pitted areas then were rebuilt & Belzona 1391T was applied to the drum.
