Weatherproofing Roof Ridge Cap

ID: 9248

Industry: Chemical & Petrochemical
Application: RPA-Roof Problem Areas
Substrate: Aluminum
Products: Belzona 3121 (MR7), Belzona 9111 (Cleaner Degreaser)

Customer Location: Decatur, Alabama
Application Date: October 2023

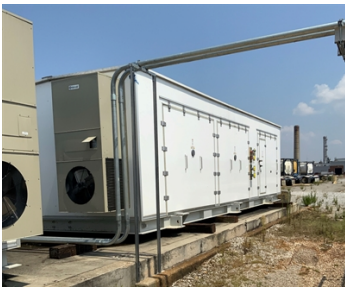
In the pictures below you will see a fiberglass housing unit for power supply in a local chemical plant. These units each have an aluminum ridge cap on the roof that comes from the manufacturer siliconed to the fiberglass panel. During transportation they become loose due to the flexibility of the fiberglass and from just being in the weather constantly the silicone deteriorates causing a leaking hazard inside the unit. This can and has caused major power outages inside the plant.

Rectifier Housing

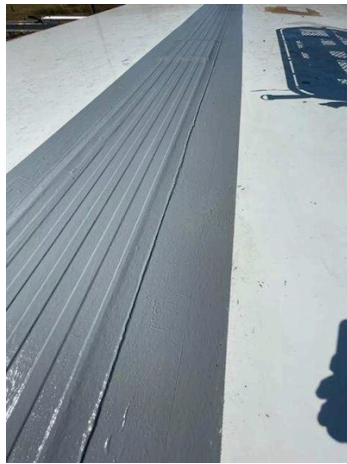
Aluminum ridge cap coated with Belzona 3121

1st step: we removed any loose silicone then prepped the fiberglass and aluminum cap with a Metabo bristle blaster.

2nd step: we then cleaned the areas with Belzona degreaser and wiped clean. Taped off each side for a perfect straight line. Then applied our first coat of Belzona Belzona 3121.

3rd step: we wet out our Belzona reinforcement cloth using Belzona 3121 and applied it to the areas that we have prepped. Once all areas have the first coat and reinforcement cloth down and no wrinkles showing we move to the final step.

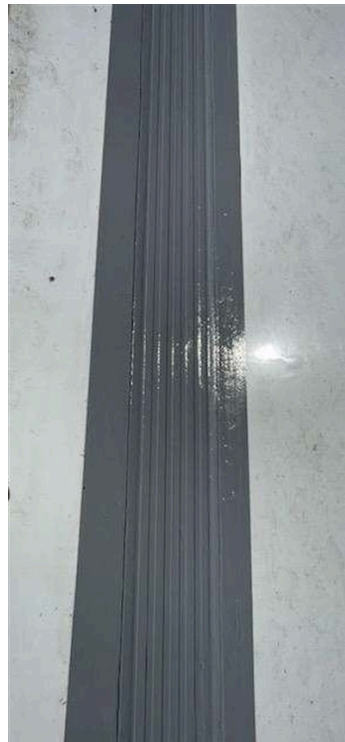
Final application

4th and final step: is to completely saturate the cloth with a second coat of Belzona 3121 making sure to coat thoroughly to properly cover the reinforcement cloth. Remove tape and Clean up!
