# Weatherproofing Roof Ridge Cap

ID: 9248

Industry:	Chemical & Petrochemical	Customer Location:	Decatur, Alabama
Application:	RPA-Roof Problem Areas	Application Date:	October 2023
Substrate:	Aluminum		
Products:	Belzona 3121 (MR7), Belzona 9111 (Cleaner Degreaser)

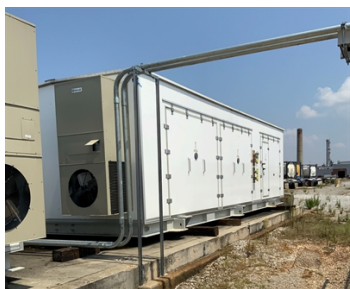
In the pictures below you will see a fiberglass housing unit for power supply in a local chemical plant. These units each have an aluminum ridge cap on the roof that comes from the manufacturer siliconed to the fiberglass panel. During transportation they become loose due to the flexibility of the fiberglass and from just being in the weather constantly the silicone deteriorates causing a leaking hazard inside the unit. This can and has caused major power outages inside the plant.

Rectifier Housing

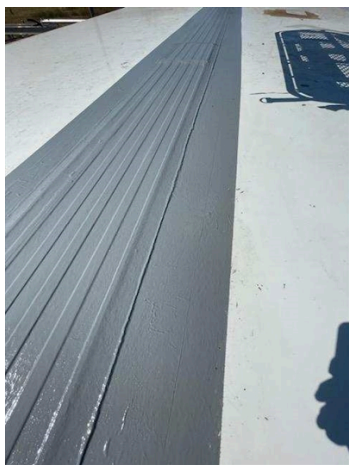
Aluminum ridge cap coated with Belzona 3121

1st step: we removed any loose silicone then prepped the fiberglass and aluminum cap with a Metabo bristle blaster.

2nd step: we then cleaned the areas with Belzona degreaser and wiped clean. Taped off each side for a perfect straight line. Then applied our first coat of Belzona Belzona 3121.

3rd step: we wet out our Belzona reinforcement cloth using Belzona 3121 and applied it to the areas that we have prepped. Once all areas have the first coat and reinforcement cloth down and no wrinkles showing we move to the final step.

4th and final step: is to completely saturate the cloth with a second coat of Belzona 3121 making sure to coat thoroughly to properly cover the reinforcement cloth. Remove tape and Clean up!

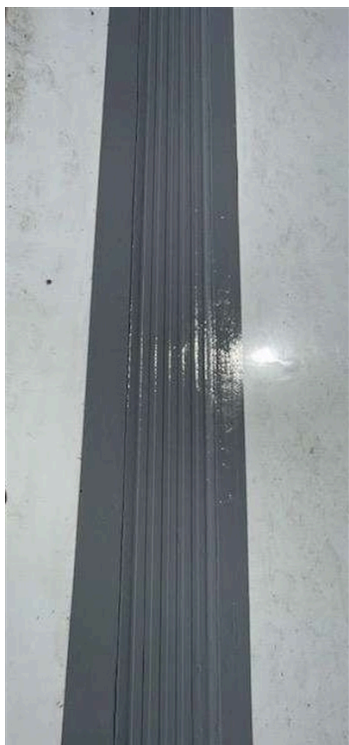
Final application
