# Weatherproofing Roof Ridge Cap

ID: 9248

Application: RPA-Roof Problem Areas

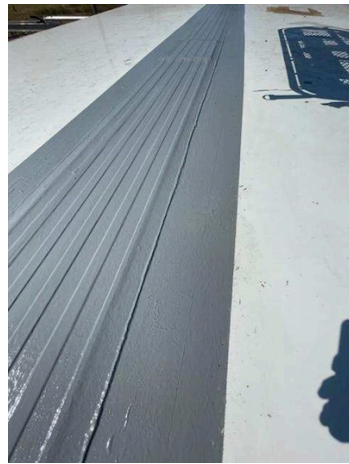
Aluminum ridge cap coated with Belzona 3121

1st step: we removed any loose silicone then prepped the fiberglass and aluminum cap with a Metabo bristle blaster.

2nd step: we then cleaned the areas with Belzona degreaser and wiped clean. Taped off each side for a perfect straight line. Then applied our first coat of Belzona Belzona 3121.

3rd step: we wet out our Belzona reinforcement cloth using Belzona 3121 and applied it to the areas that we have prepped. Once all areas have the first coat and reinforcement cloth down and no wrinkles showing we move to the final step.

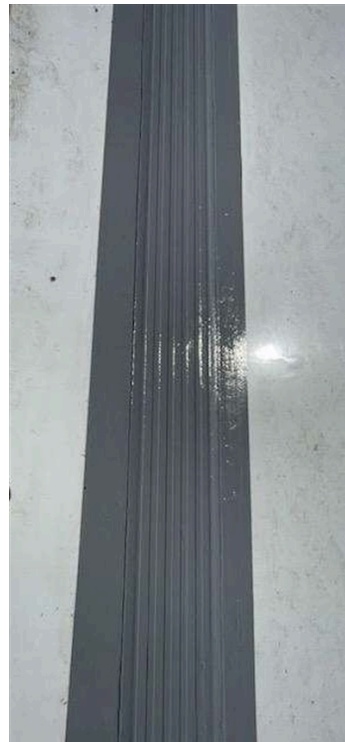
Final application

4th and final step: is to completely saturate the cloth with a second coat of Belzona 3121 making sure to coat thoroughly to properly cover the reinforcement cloth. Remove tape and Clean up!
