# Belzona repairs 600-metre long Steel plant conveyor belt

ID: 9249

Application: SHM-Solids Handling Machinery

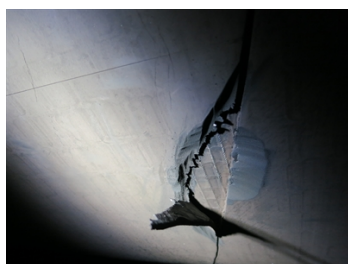
The 600-metre long conveyor belt transports the iron ore to the blast furnace. The belt costs more than 200.000 euros. It takes at least 2 days to replace it. The loss of production costs about 100.000 euros per hour !!!!. After about 8 years of operation, the belt was already so badly worn in some places that the steel belts had become visible.

Conveyor Belt to repair.

The client tested all the rapid repair systems available on the market. Belzona 2111 and Belzona 2311 performed very well. All other systems had either too little adhesion or less wear resistance. The production downtime for repairs in the summertime was only 8 to 10 hours. We also had repairs in wintertime at minus 15°C. On these occasions, we had to build housing and heat the repair area with propane gas burners to get heat and also enough humidity to dry the primer 2911.

The application was carried out in accordance with Belzona system leaflet SHM-1 • FOR REPAIRING RIPPED, TORN AND WORN CONVEYOR BELTS

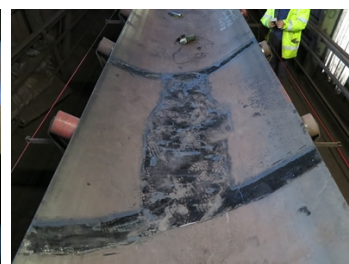
Damage to Belt
