# Belzona repairs 600-metre long Steel plant conveyor belt

Application: SHM-Solids Handling Machinery

Application Date: February 2015

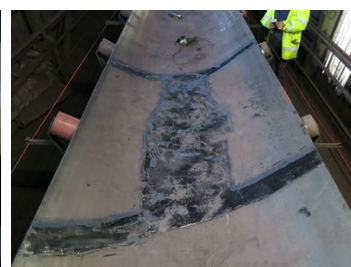
Completed Application

The client tested all the rapid repair systems available on the market. Belzona 2111 and Belzona 2311 performed very well. All other systems had either too little adhesion or less wear resistance. The production downtime for repairs in the summertime was only 8 to 10 hours. We also had repairs in wintertime at minus 15°C. On these occasions, we had to build housing and heat the repair area with propane gas burners to get heat and also enough humidity to dry the primer 2911.
