SANDSTONE MULLION REPAIRS WITH BELZONA

ID: 925

Application: *WPA-Wall Problem Areas*

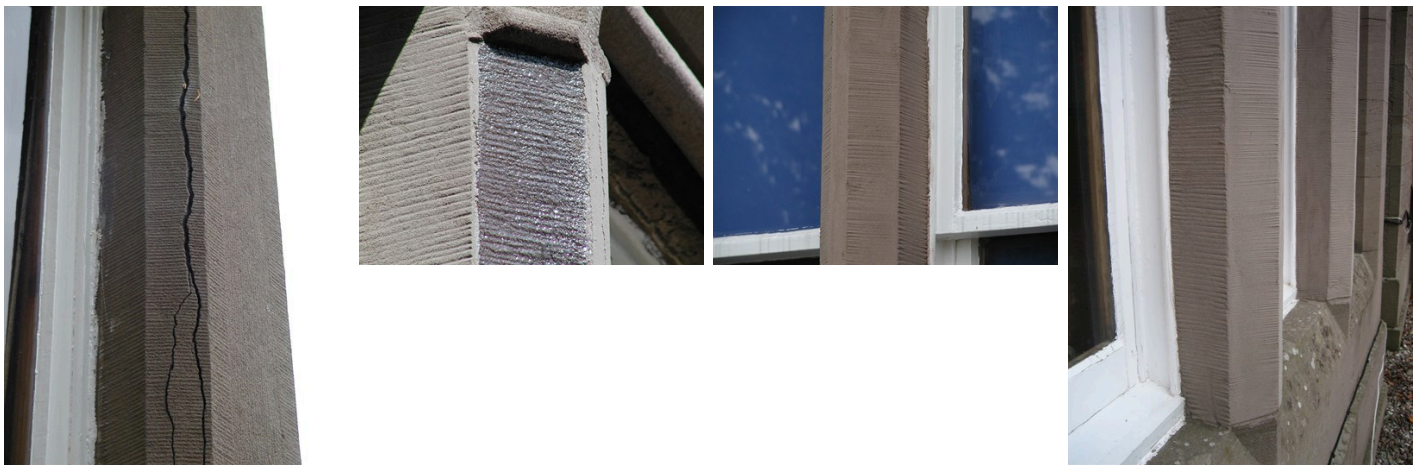
The cracks were getting worse due to frost damage in the winter months and previous attempts at concrete repairs had failed at the bond lines.

- * The problem. Note the grooving of the sandstone. ,
- * Belzona® 4141 being applied as a skim coat. ,
- * Finished application. ,
- * Inspected December 2007. ,

Householder had a problem of cracks in the sandstone Mullions of his bay windows.

Application was carried out in accordance with Belzona Know-How System Leaflet WPA-4. The cracks were opened out and filled prior to the whole mullion being skimmed with Belzona® 4141 tinted to match the colour. The original grooving on the stone was replicated in the Belzona® 4141.
