SANDSTONE MULLION REPAIRS WITH BELZONA

ID: 925

Industry: *Buildings & Structures*

Application Date: *July 2003*

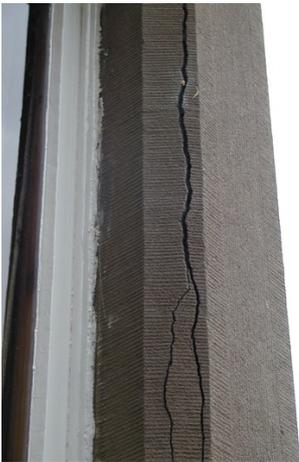
The cracks were getting worse due to frost damage in the winter months and previous attempts at concrete repairs had failed at the bond lines.

- * The problem. Note the grooving of the sandstone. ,
- * Belzona® 4141 being applied as a skim coat. ,
- * Finished application. ,
- * Inspected December 2007. ,

Householder had a problem of cracks in the sandstone Mullions of his bay windows.

Application was carried out in accordance with Belzona Know-How System Leaflet WPA-4. The cracks were opened out and filled prior to the whole mullion being skimmed with Belzona® 4141 tinted to match the colour. The original grooving on the stone was replicated in the Belzona® 4141.
