Belzona 5811 & 3121 Seals Stair Landing from Future Leaks

ID: 9257

Customer Location: Birmingham, AL
Application Date: January 2024

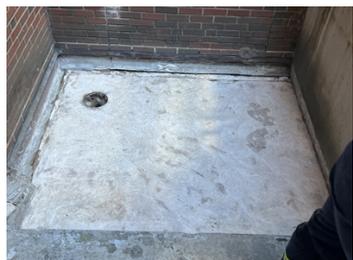
Old Coating was removed and floor was taken to bare concrete by a diamond grinder.

After removing the thick mat-like coating that had bubbled and failed, we prepared the concrete floor and 8" up the wall with a diamond grinder to achieve desired substrate. We then proceeded with building a 2" cove out of Belzona 4111 to the seam where the wall meets the floor on all sides. Next, we applied 1 coat of Belzona 5811 to the floor and up the walls 8". After curing we painted an 8" strip bridging the floor to the wall out of Belzona 3121 engrained into reinforcement cloth finishing with a second coat of Belzona 3121. 3 weeks later and heavy rains, they are not experiencing any more leaks.

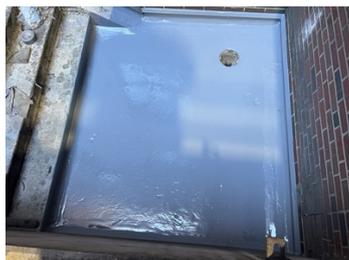
Belzona 5811 as our base coat to the "basin"

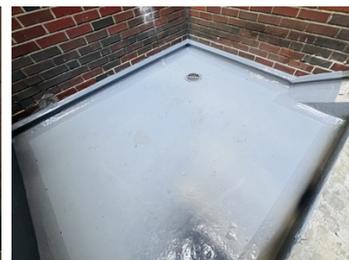
Final product
