Belzona 5811 & 3121 Seals Stair Landing from Future Leaks

ID: 9257

Industry: *Buildings & Structures*
Application: *FPA-Floor Problem Areas*
Substrate: *Concrete*
Products: *Belzona 3121 (MR7), Belzona 4111 (Magma-Quartz), Belzona 5811 (Immersion Grade)*

Customer Location: *Birmingham, AL*
Application Date: *January 2024*

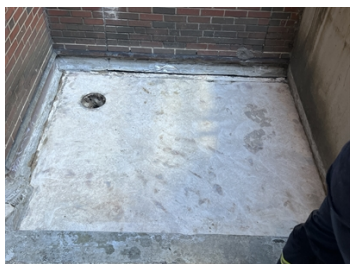
Old Coating was removed and floor was taken to bare concrete by a diamond grinder.

After removing the thick mat-like coating that had bubbled and failed, we prepared the concrete floor and 8" up the wall with a diamond grinder to achieve desired substrate. We then proceeded with building a 2" cove out of Belzona 4111 to the seam where the wall meets the floor on all sides. Next, we applied 1 coat of Belzona 5811 to the floor and up the walls 8". After curing we painted an 8" strip bridging the floor to the wall out of Belzona 3121 engrained into reinforcement cloth finishing with a second coat of Belzona 3121. 3 weeks later and heavy rains, they are not experiencing any more leaks.

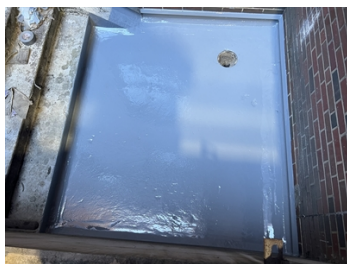
Belzona 5811 as our base coat to the "basin"

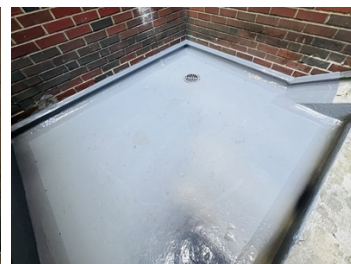
Final product
