BELZONA SUPERWRAP II DESIGN SOLUTION

ID: 9259

Industry: Oil & Gas
Application: VPF-Valves, Pipes and Fittings
Substrate: Carbon steel
Products: Belzona 1212, Belzona 1983 (SuperWrap II), Belzona SuperWrap II, Belzona 9111 (Cleaner Degreaser)

Customer Location: Fredericia, Denmark
Application Date: August 2023

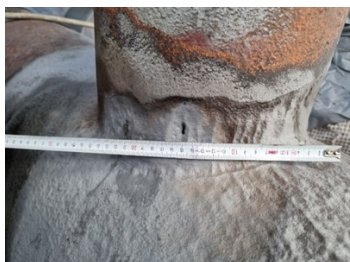
The refinery was experiencing corrosion on their pipe at a port terminal, which required either a large maintenance shutdown, or an alternative solution had to be found.

Damaged pipe

First, the pipe was gritblasted and cleaned with Belzona 9111. Belzona 1212 was used to rebuild the pipe to its original size. Belzona 1983 was chosen as the resin for the project, superwrap was carried out according to specifications, by certified SuperWrap II installer and supervisor.

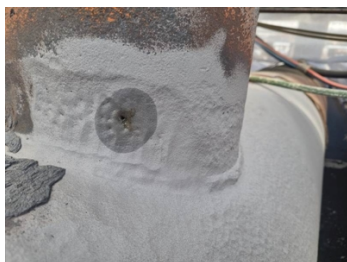
Damaged pipe

Since the thickness of the pipe was dangerously low, the customer had to find a durable solution. Either the pipe had to be changed or they had to think of alternative solutions. When the customer heard how they could save time on the repair and at the same time get an ASME PPC 2 compliant solution, the customer had no doubts.

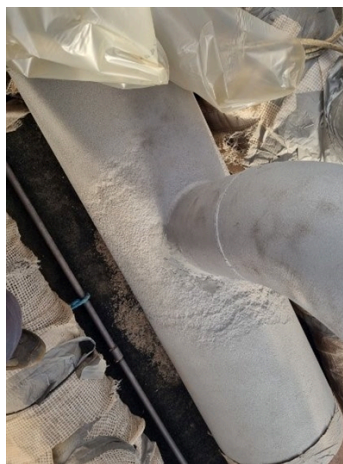
Blasted pipe, ready for superwrap

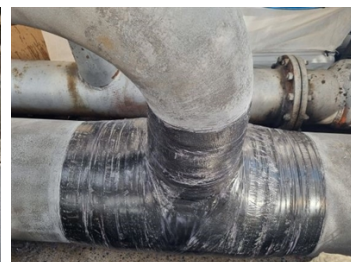
Superwrap installed

Changing a pipe with a branch is a costly affair and requires a long shutdown. Belzona was chosen for the quick solution, and the solution is compliant with ASME PPC 2, which gave the customer the necessary security for the repair. The repair was designed so that all requirements from the customer are met.
