BELZONA SUPERWRAP II DESIGN SOLUTION

ID: 9259

Industry: Oil & Gas
Application: VPF-Valves, Pipes and Fittings
Substrate: Carbon steel
Products: Belzona 1212, Belzona 1983 (SuperWrap II), Belzona SuperWrap II, Belzona 9111 (Cleaner Degreaser)

Customer Location: Fredericia, Denmark
Application Date: August 2023

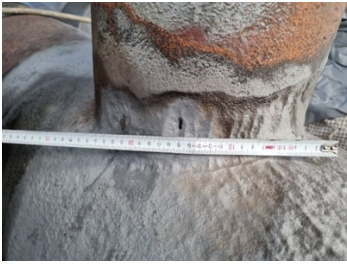
The refinery was experiencing corrosion on their pipe at a port terminal, which required either a large maintenance shutdown, or an alternative solution had to be found.

Damaged pipe

First, the pipe was gritblasted and cleaned with Belzona 9111. Belzona 1212 was used to rebuild the pipe to its original size. Belzona 1983 was chosen as the resin for the project, superwrap was carried out according to specifications, by certified SuperWrap II installer and supervisor.

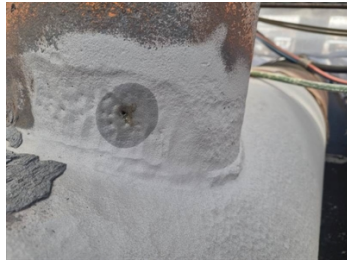
Damaged pipe

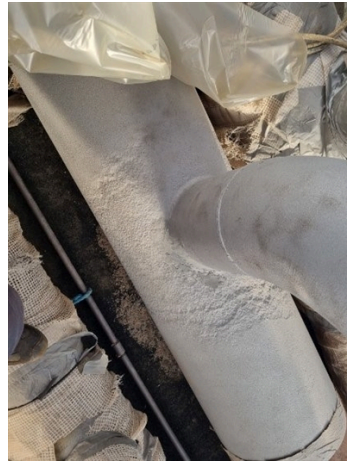
Blasted pipe, ready for superwrap

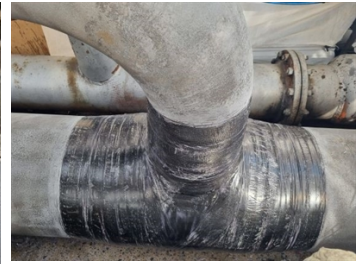
Superwrap installed

Changing a pipe with a branch is a costly affair and requires a long shutdown. Belzona was chosen for the quick solution, and the solution is compliant with ASME PPC 2, which gave the customer the necessary security for the repair. The repair was designed so that all requirements from the customer are met.
