# BELZONA PROTECTION FOR GEARBOX INTERNAL

ID: 926

Customer Location: Power Station, UK  
Application Date: February 2007

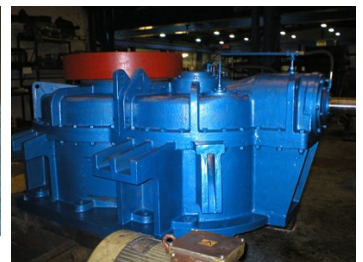
Internal protection required by client to ensure long service life. Previous coatings had failed prematurely causing bearing failure and oil seal damage.

\* Bare gearbox in workshop , \* Application of Belzona® 5891 underway , \* Application complete , \* Assembled gearbox ready for service ,

Fifteen ton gearbox from ball mill used to pulverize coal.

The application was carried out in accordance with the Belzona Know-How System Leaflet TCC-5. Special attention was paid to surface preparation, particularly with regard to removing all impregnated oil and achieving correct grit blast profile.
